# Manhole Inspection Summary

Manhole # S29YY\_036MH

**Location** Address: **631 33RD ST**

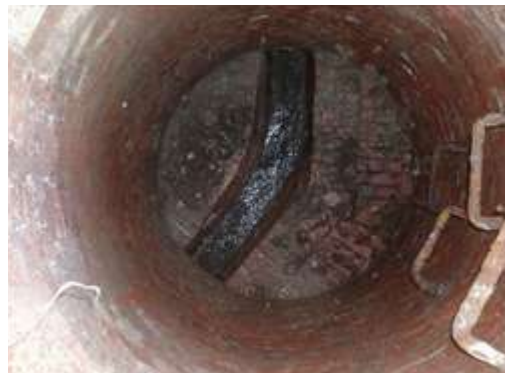
Top View

Evidence of surcharge - Bench debris.  
Corroded steps.

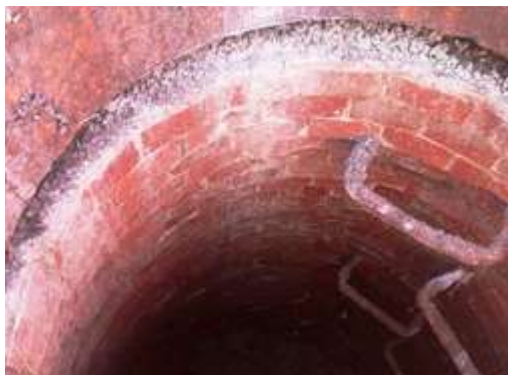
Defect

Adjustment deterioration and infiltration.  
Corbel and Barrel infiltration - other side.

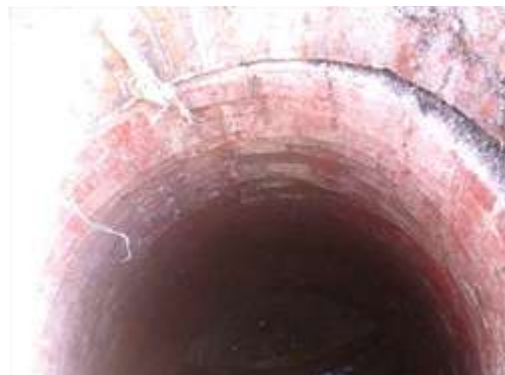
Defect

Adjustment deterioration, root intrusion  
and infiltration. Corbel and Barrel  
infiltration.

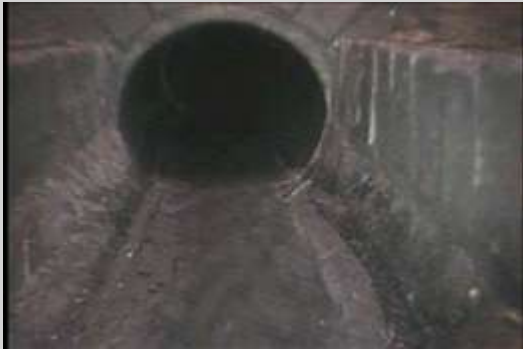
### 10 in. Circular Gravity Sewer Pipe Out @ 12 O'Clock

Infiltration: **None** Pipe Seal Cond: **Unknown**

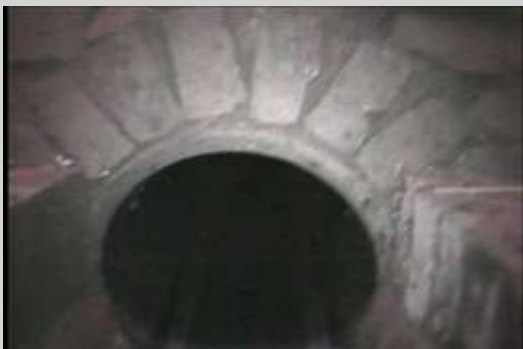
### 10 in. Circular Gravity Sewer Pipe In @ 7 O'Clock

Infiltration: **None** Pipe Seal Cond: **Unknown**
